Protecting the Beauty Within

A Gallery's Skylight Retrofit Keeps Historic Look, Adds Modern Performance

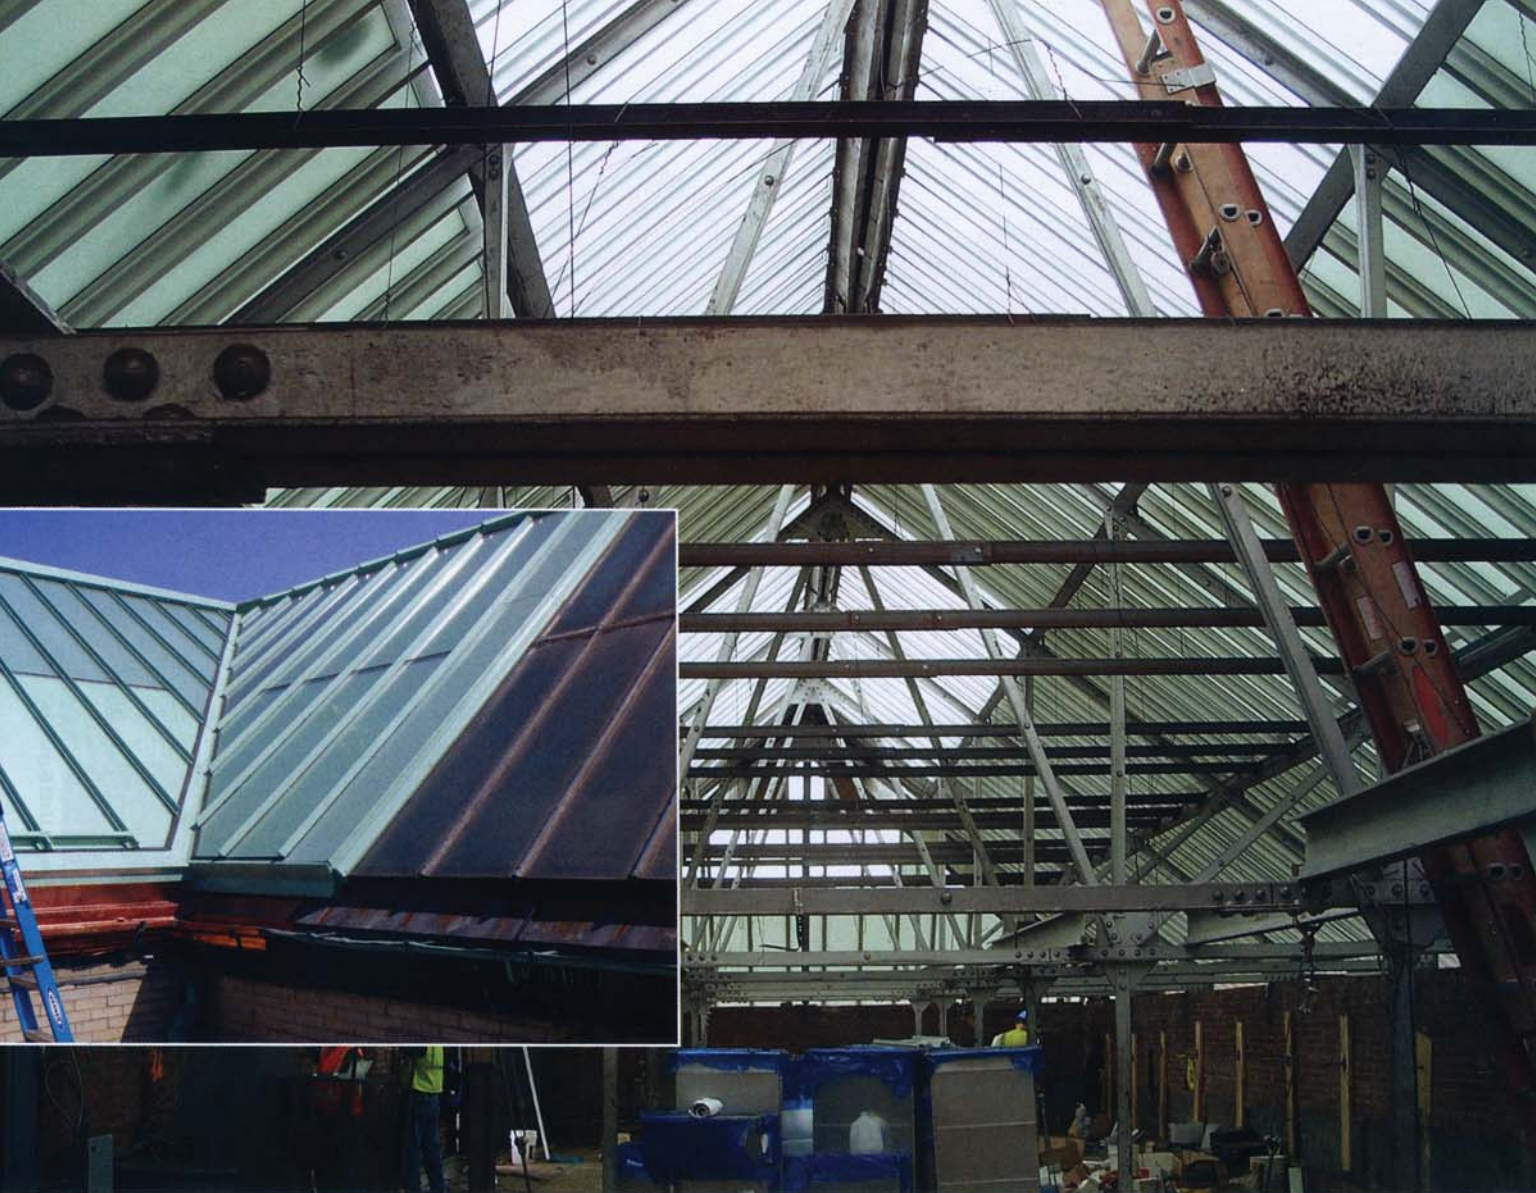
The Corcoran Gallery's original wired glass skylight was replaced with laminated insulating glass units.

building envelope," Petzen adds. "Half-inch wired glass isn't very thermally efficient. Going to high performance low-E and ceramic frit accomplished that for them."

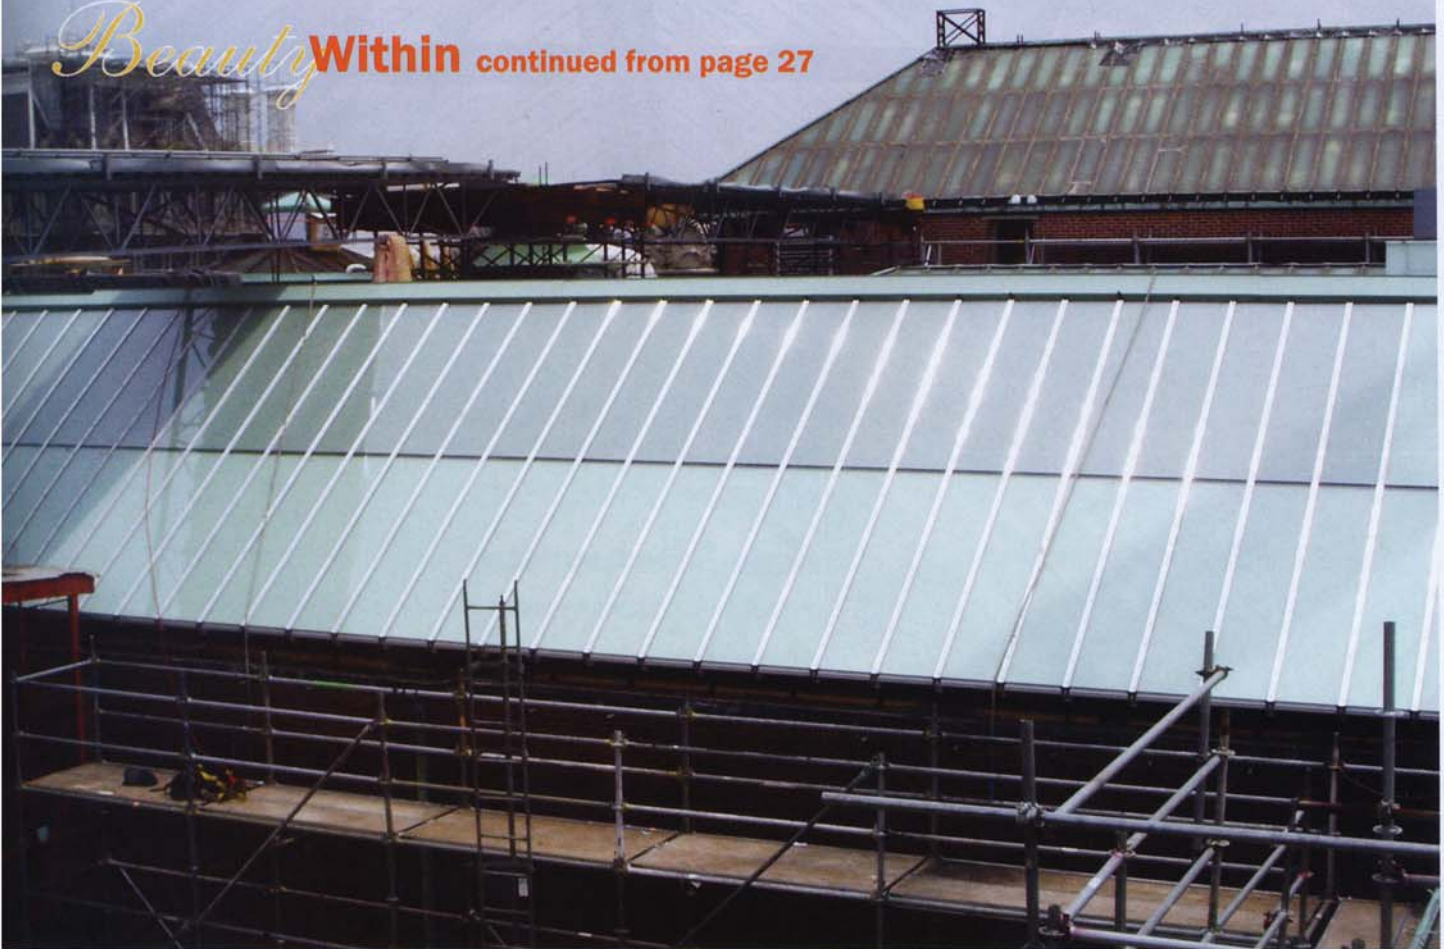
The new skylight, pictured in the foreground, is better able to protect this gallery's artwork than the original skylight (seen in the background).
